Morphology And Morphometry Of A Channelized Stream: The Case History Of Big Pine Creek Ditch, Benton County, Indiana, Studies In Fluvial Geomorphology No. 4

MORPHOLOGY AND MORPHOMETRY OF A CHANNELIZED STREAM:
THE CASE HISTORY OF BIG PINE CREEK DITCH, BENTON COUNTY, INDIANA

This is a partial completion report for
OWRT Project No. A-035-IND (Agreement No. 14-34-0001-6015)
entitled "Channel Morphology, Stream Power, and Sediment
Types as Related to Channelization and River Training"

Technical Report No. 92
Purdue University Water Resources Research Center
West Lafayette, Indiana

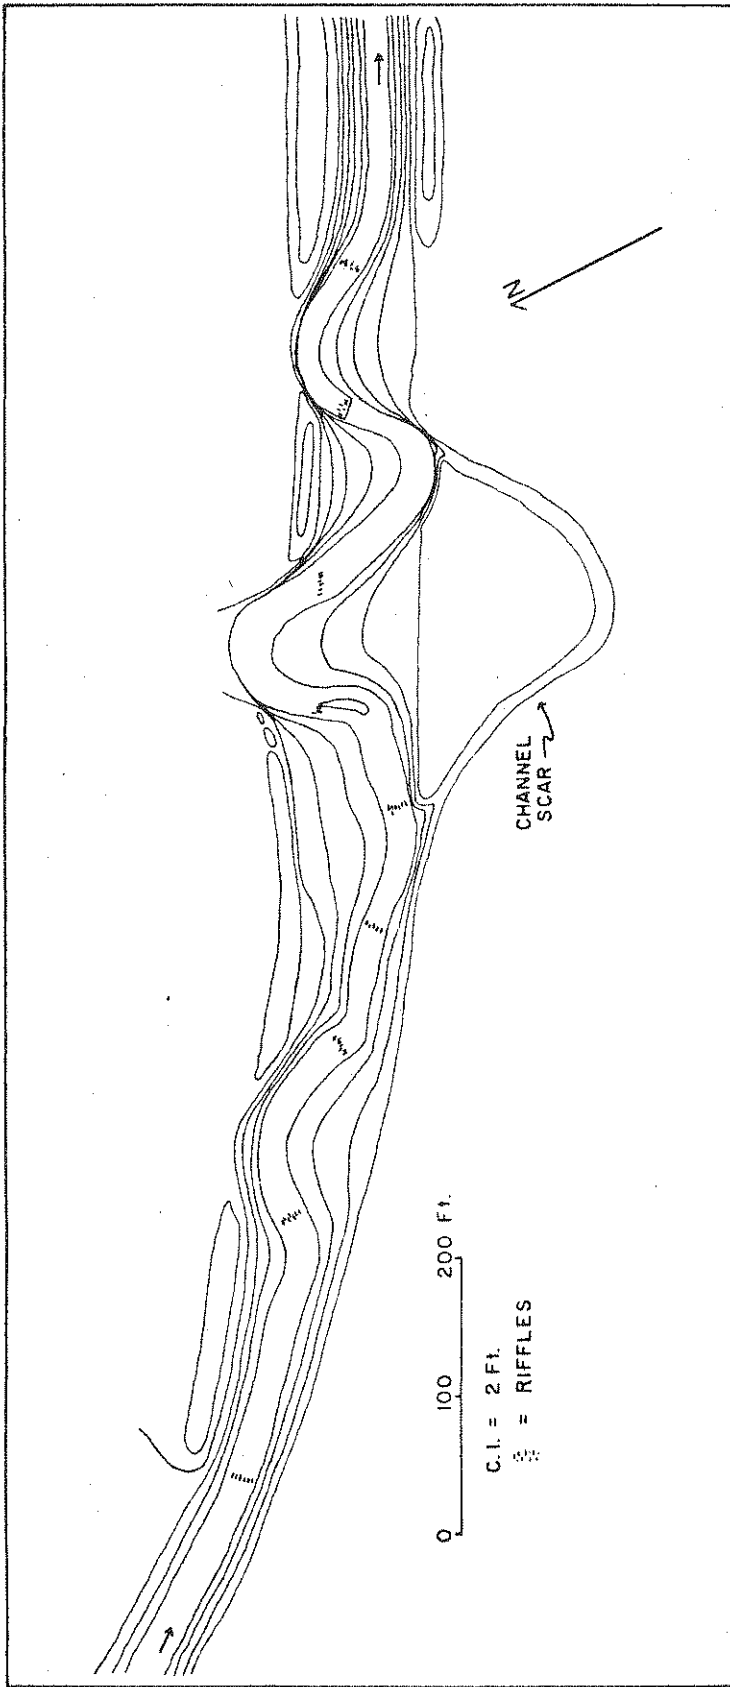
In the Fall of 1975, the reach of channel in Section 34 that is experiencing excessive bank erosion was surveyed in considerable detail (Figure 6). Mapping interval was two feet, which shows quite clearly the bank cutting taking place on the outside of the meanders, and point bar deposition on the inside of bends (see Figures 7 and 8). Sinuosity of the reach has developed to approximately 1.2 in only 40 years. Figure 9 is a profile of the channel bottom through this reach, indicating the advanced stages of pool-riffle

Figure 6 Map of survey reach (1975) in Section 34 showing channel deterioration.

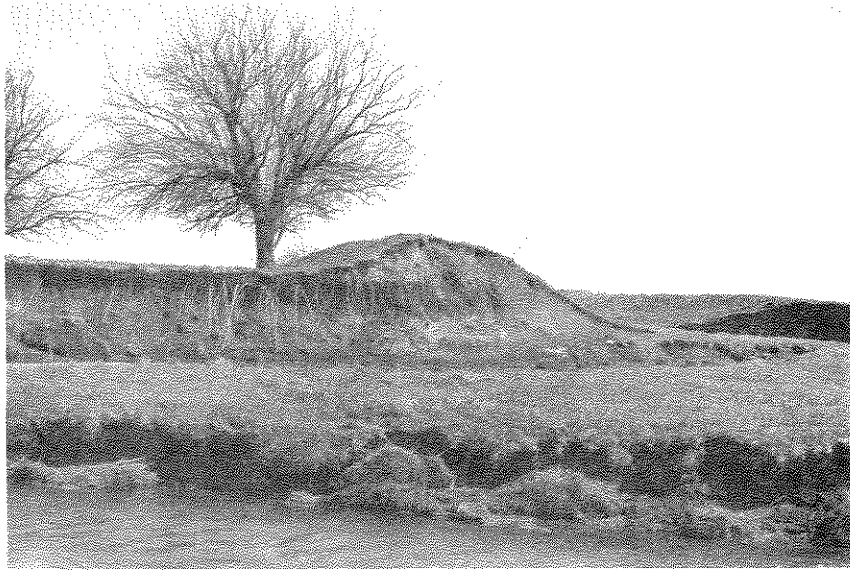
Figure 7 Downstream view in the survey reach showing bank erosion and vegetated point bar.

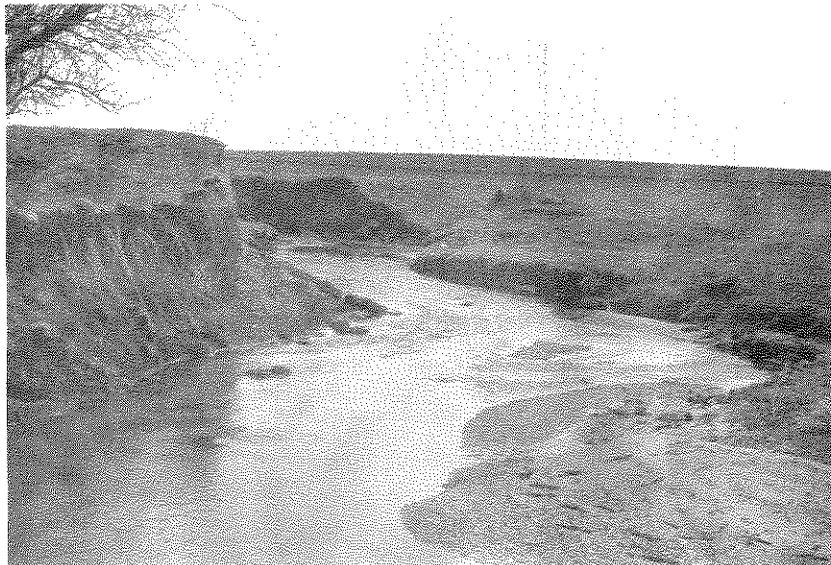
Figure 8 Downstream view in the survey reach showing bank erosion, point bar deposition, and riffle formation.

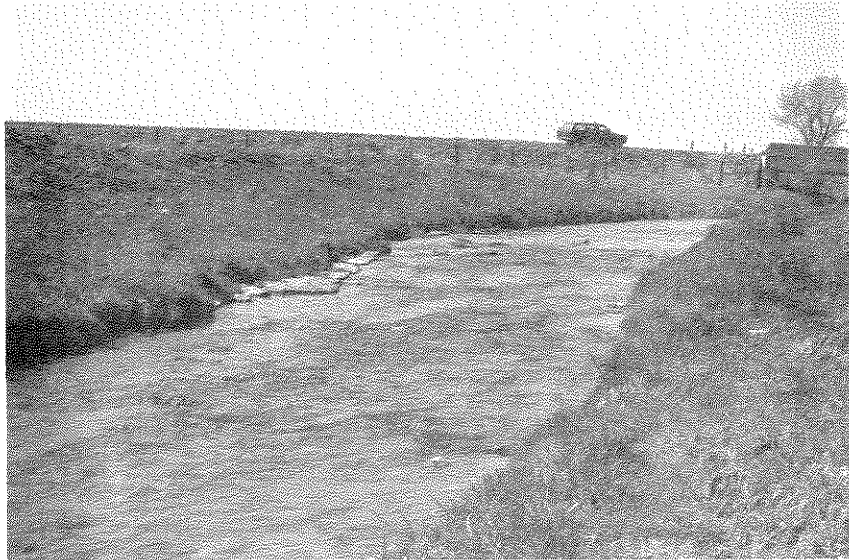
Close inspection of the Big Pine knickpoint shows very similar elements upstream and downstream from the bedrock high. Downstream incision is evident and seems to continue on to the outlet of the stream; this may have resulted from a lowering of local base level, by main stream modification in that area (see Figures 11 and 12).

Figure 11 Upstream view just above knickpoint, showing bedrock in channel and steepened reach.

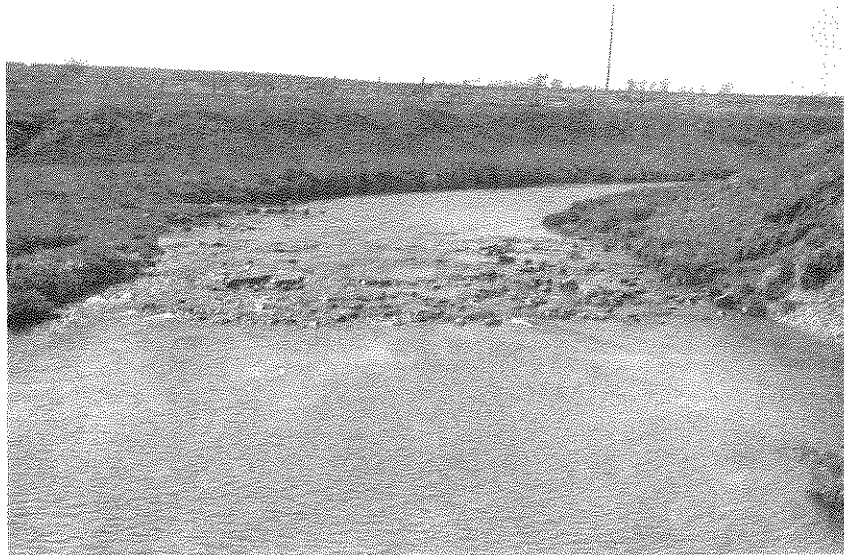
Figure 12 Upstream view of the knickpoint formed at bedrock termination.

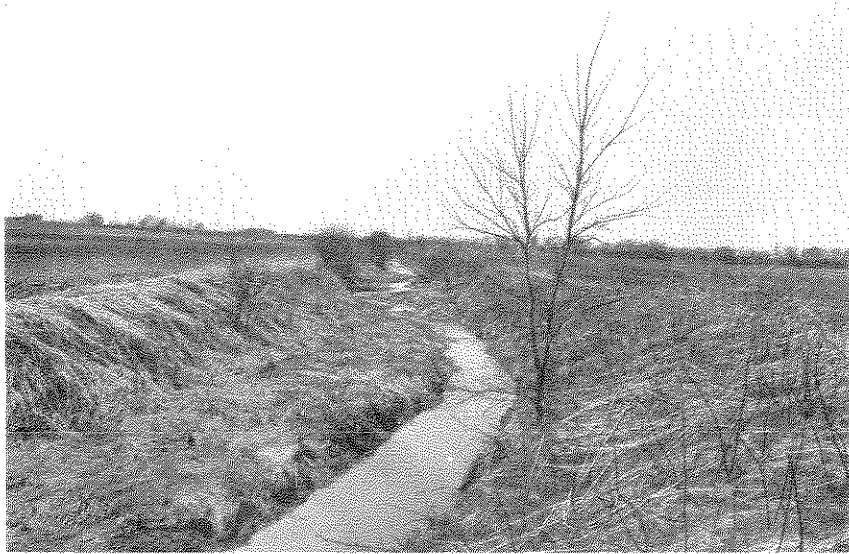
Figure 14 Upstream view in Section 24, T26N, R8W, near headwaters of Big Pine Creek Ditch, showing minor bank deterioration and a meandering low-water channel.

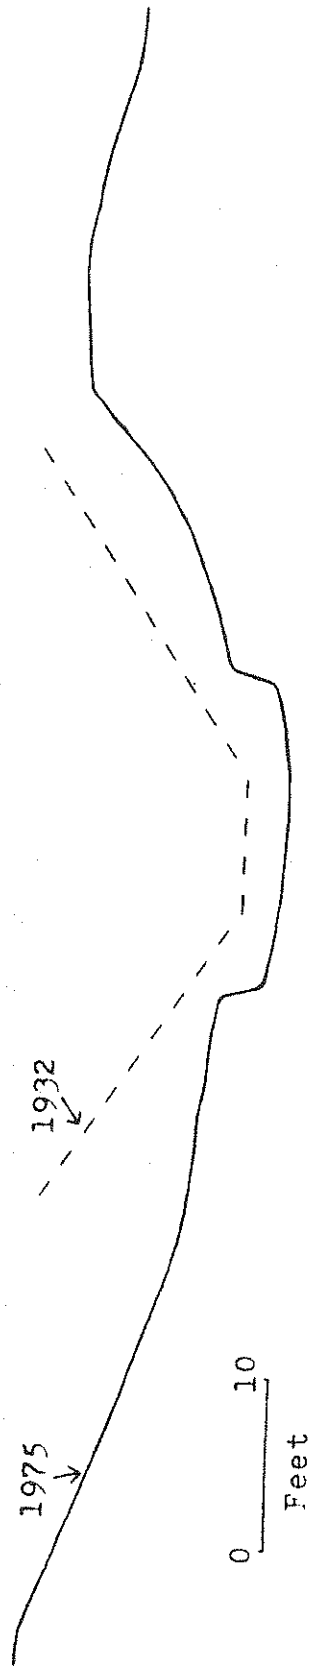
causing undercutting and bank collapse, and point bar deposition on the inside of meander bends. Figures 15 and 16 were both constructed in straight reaches of the survey area in Section 34 (Figure 15 at the upstream end, Figure 16 at the downstream end). They show little lateral shifting of the channel, but considerable bank deterioration and retreat by means of slope creep and erosion. Near the east end of Section 34, the channel is experiencing lateral migration in the form of a series of rather tight meander bends. Figure 13b shows considerable migration of the channel on the meander bend itself. The principal erosional forces appear to be undercutting and bank slumping, with slump blocks often being evident in the channel. Figure 13c, again in a straight reach near the outlet in Section 1, shows the greatest amount of channel cross-sectional enlargement, and five to six feet of entrenchment.

Figure 16 Cross-section at downstream end of the survey reach showing downcutting of the channel.

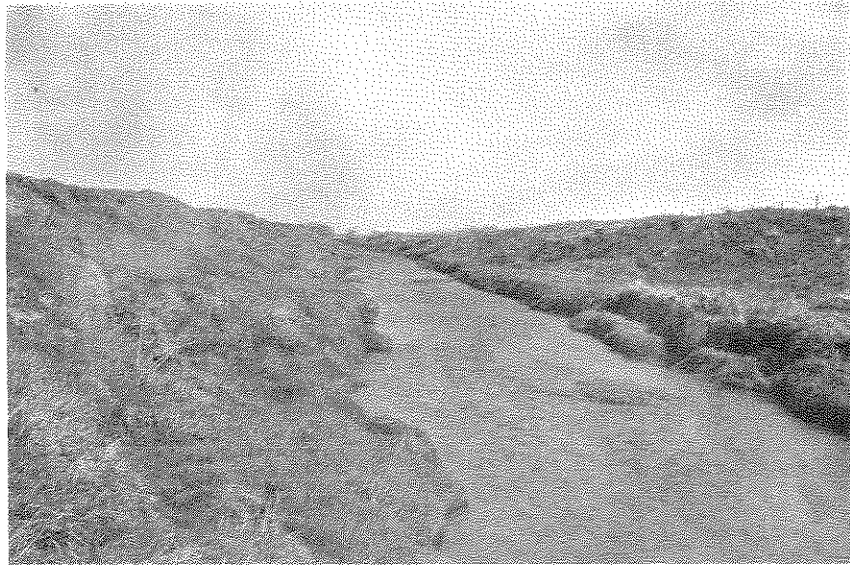
Figure 18 Downstream view of the reach in Section 35, T26N, R7W, recently restraightened and already showing asymmetric shoal development.

water channel shows asymmetric shoals and an alternating thalweg.

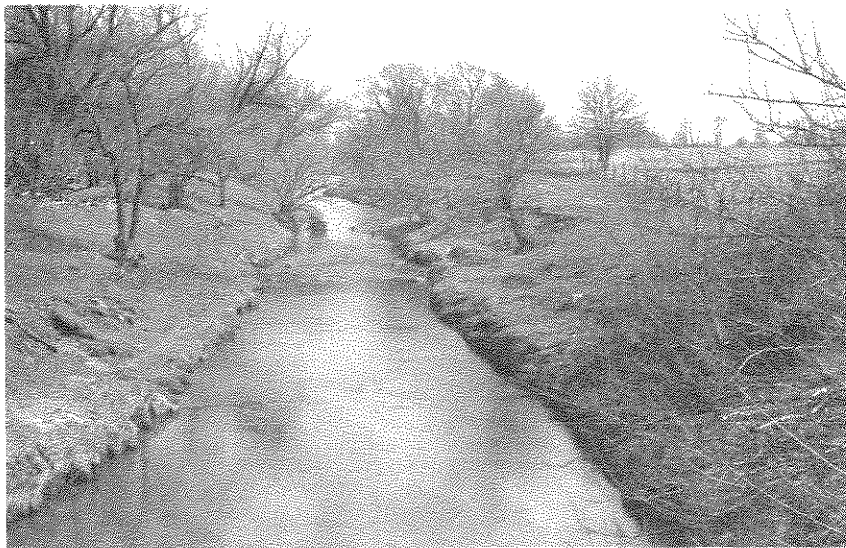
Figure 19 Downstream view in Section 1, T25N, R7W, showing a well developed riffle and no meander development. Attention is brought to bank slumping and slope creep.

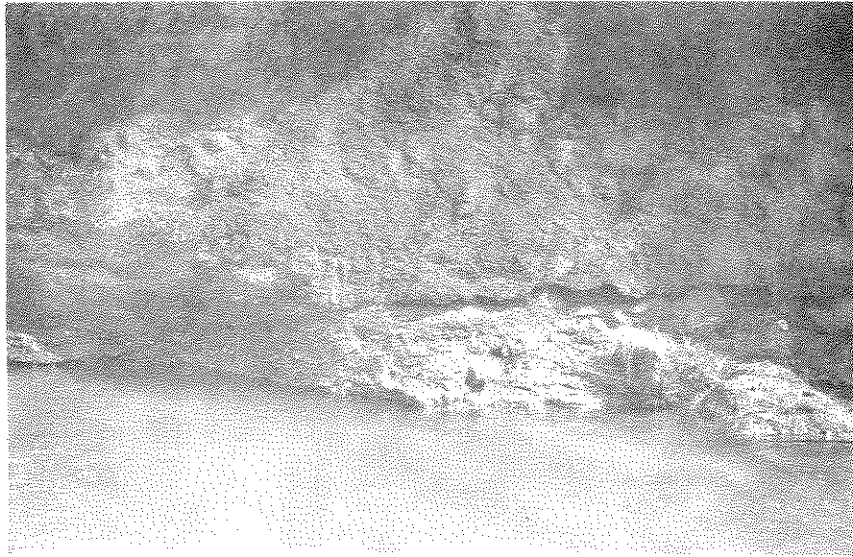
Figure 20 Typical subsurface sand lens exposed in cut banks along Big Pine Creek Ditch.

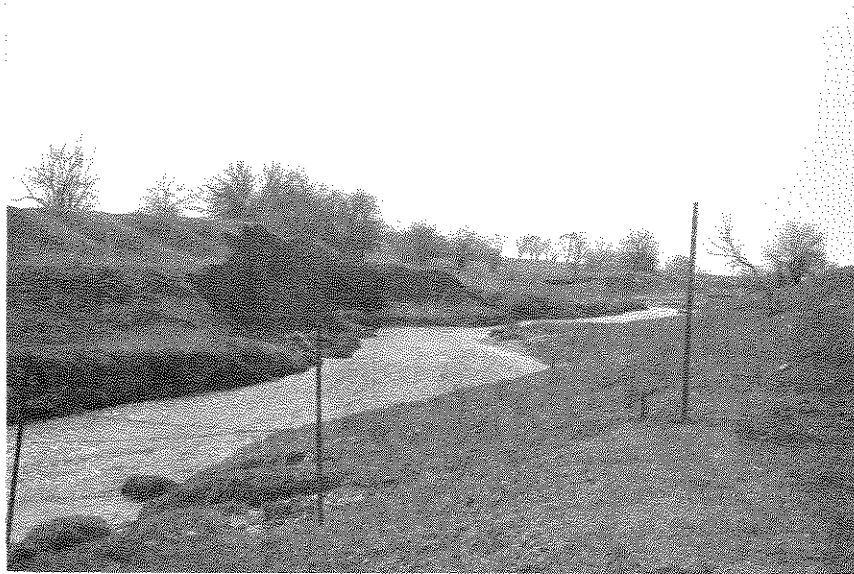
As previously mentioned, spoils were neither evenly distributed nor consistently used to fill the pre-existing channel. In some sectors, spoils still create somewhat of a barrier to drainage of adjacent fields, whereas elsewhere spoils appear nonexistent. An in-depth study of spoil bank effect on stream stability is presently not feasible, as the banks have been modified by erosion and cultivation practices and, in some reaches, have been entirely removed for use in road construction (see Figure 21).

Figure 21 Upstream view in Section 1, T25N, R7W, demonstrating uneven distribution of spoils.
